Pianocorder™
Reproducing System

SERVICE BULLETIN

model number P-100, P-100M	bulletin number 00018
for serial numbers	
subject PROBLEMS WITH KEYSWITCHES AND THEIR SOLUTIONS	
technical services approval <i>J. R. T.</i>	writer <i>J. R. T.</i>
engineering approval <i>J. R. T.</i>	date 4/3/80

PROBLEMS ENCOUNTERED WITH KEYSWITCHES AND THEIR SOLUTIONS

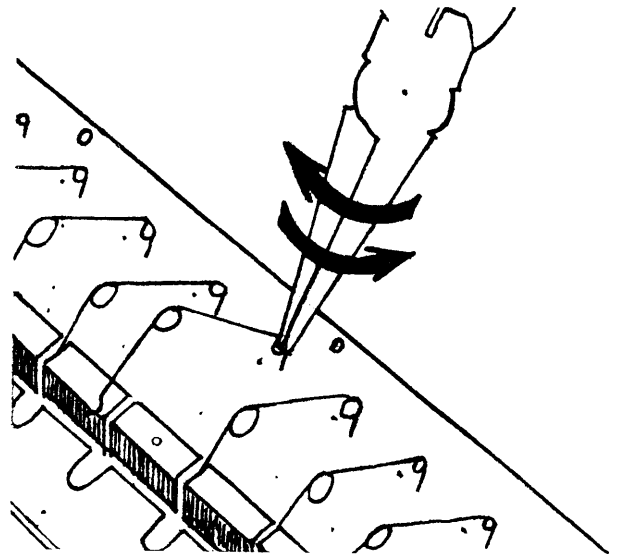
3. The keyswitch is torqued in its plastic guide slot. This condition is not apparent upon first inspection of the keyswitch boards. To spot it, carefully lift each keyswitch wiper up onto the top of the dust cover. Each wiper should stand directly over its slot. If it twists off to one side when the switch is lifted, the switch is torquing. Using a pair of needle-nosed pliers gently twist the stem and small loop until the wiper remains standing over the center of its slot when released. This procedure will eliminate most of your phantom double-note problems.
